FULL RESERVE STUDY

*SETTLERS POINTE
LEXINGTON, SC*

Prepared for:
**SETTLERS POINTE HOMEOWNERS ASSOCIATION
LEXINGTON, SC**

Prepared by:
**CRITERIUM – GILES ENGINEERS
7334 CHAPEL HILL ROAD, SUITE 200
RALEIGH, NC 27607
(919) 465-3801**

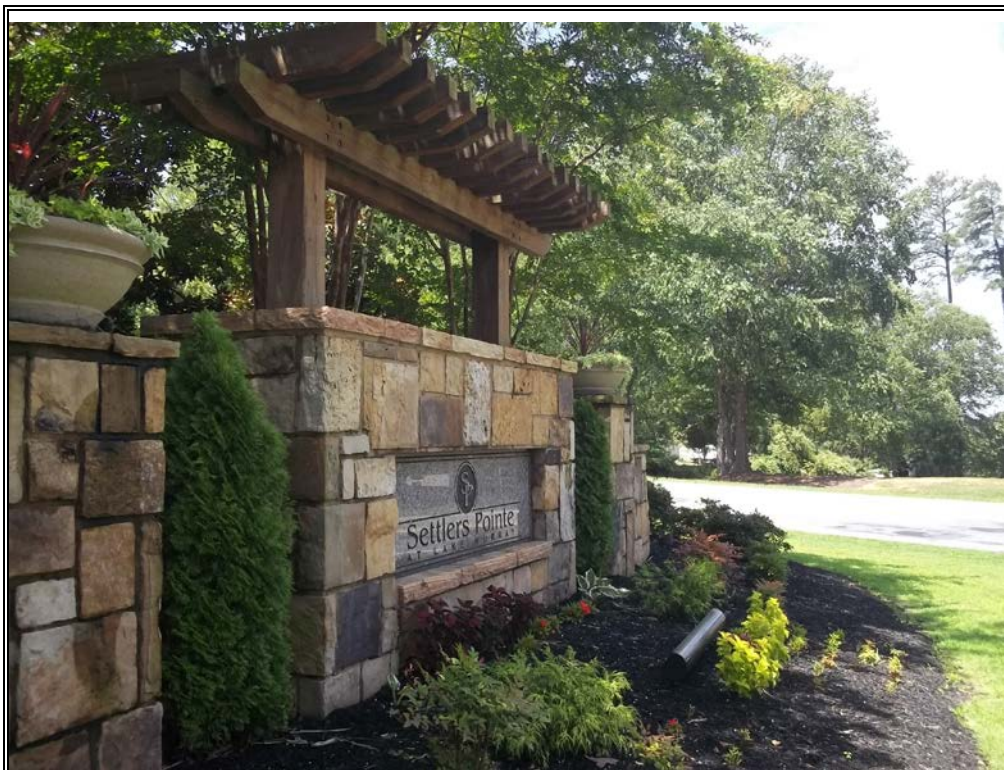
Photo Number
2

Description:
View of monument
entrance sign.

Monument entrance sign structures are located at the entrance to the community at Settlers Trail and Pilgrim Church Road. The monument signs are of masonry construction with stone veneer and include a small wood pergola. An engraved stone sign inlay is installed at the entrance sign. The entrance monuments generally appeared to be in good condition. We have allocated funds to repair the entrance monuments on a 20 year cycle beginning in 2029. We have assumed that repairs to the small wood pergola at the entrance sign would be funded from an annual maintenance budget.

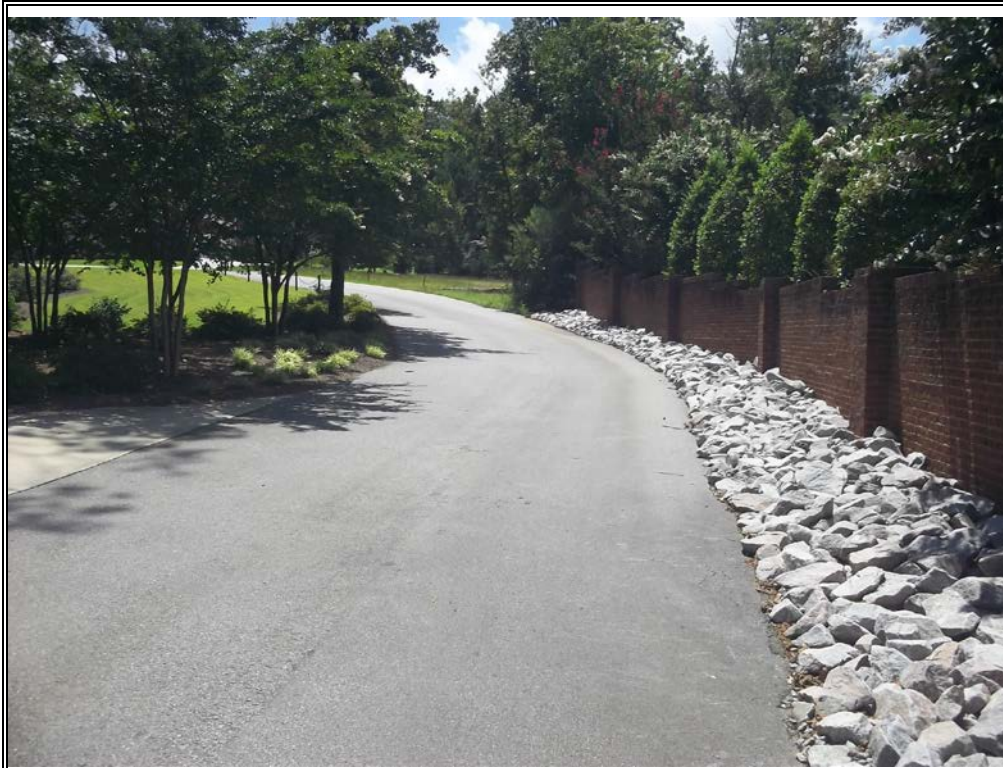
Photo Number
3

Description:
Asphalt paved
drive aisle at boat
ramp.

The streets throughout the community are asphalt paved and publicly maintained. The association is responsible for maintaining the asphalt paved drive aisle and circle at the boat dock. The paving generally appeared to be in good condition. However, the paving does not appear to have been seal coated since original construction. We observed minor cracking in limited areas of the paving developing.

Typically, we recommend the periodic application of a crack filler in asphalt paved surfaces. The crack filler will reduce water infiltration through cracks as they develop and prolong the useful life of the paving. In addition to crack filling, we recommend sealcoating and restriping on an approximately 7 year cycle. We have allocated funds for crack filling and sealcoating beginning in 2017 and continuing on a 7 year cycle.

Assuming crack filling and seal coating are completed in the interim, we anticipate the asphalt paving to have a remaining useful life of approximately 15 years prior to resurfacing. Resurfacing would typically include repairing and sections of fatigue cracking, surface preparations and the installation of a 1" to 2" thick layer of asphalt over the existing paving. We have allocated funds for resurfacing the paved parking area/drive aisle in 2032.

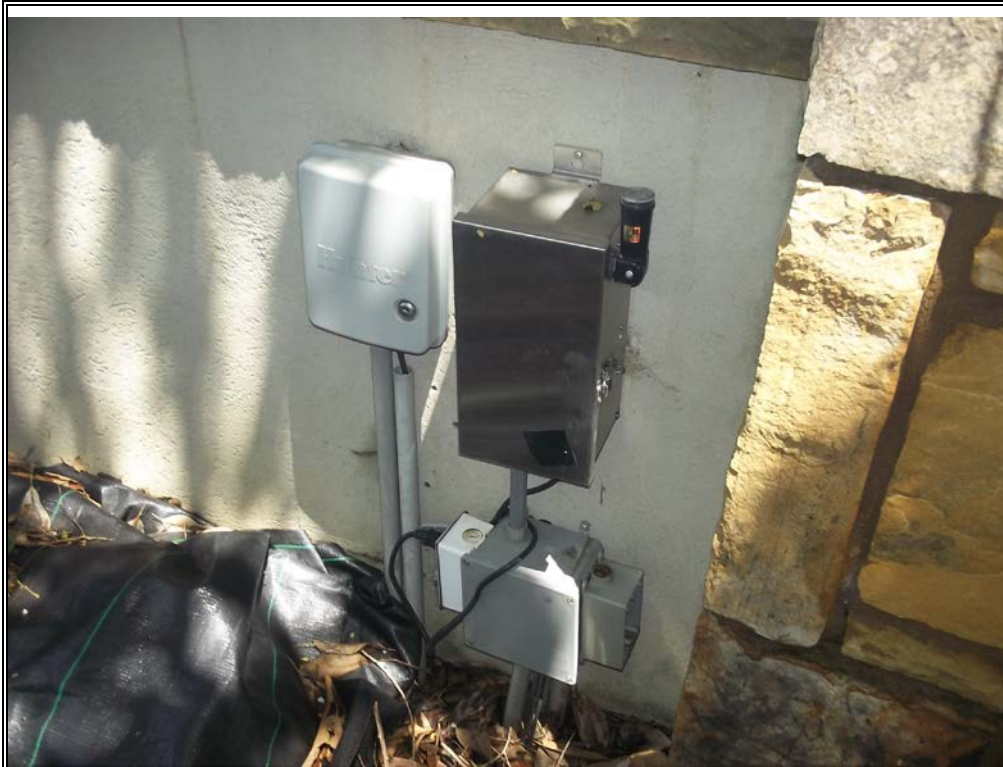
Photo Number
6

Description:
Landscape
irrigation and
lighting controls at
entrance sign.

The entrance areas include a landscape lighting and irrigation systems. The lighting systems include a meter, breaker panel and low-voltage transformer along with numerous light fixtures. The irrigation systems include a backflow preventer and controllers. We have allocated funds to

refurbish the lighting system and repair the irrigation systems on a 12 year cycle beginning in 2023.

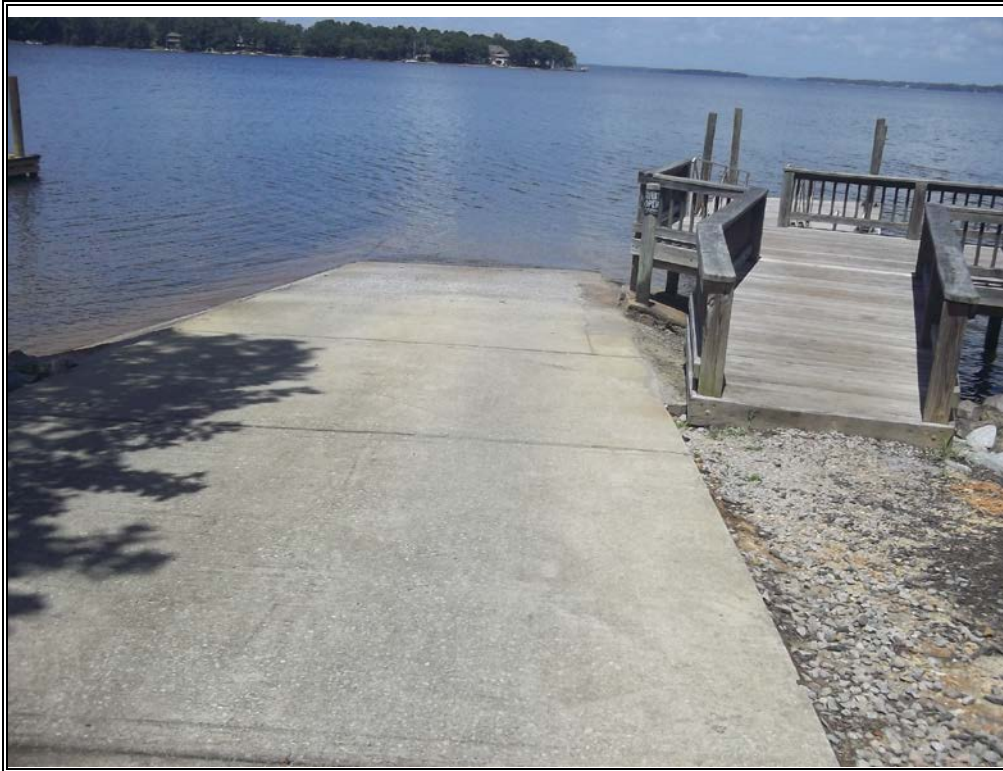
Photo Number
7

Description:
Boat ramp.

The association maintains the concrete boat ramp on Lake Murray. The visible portions of the concrete boat ramp generally appeared to be in good condition with no significant cracking observed. It is likely that cracking will develop over time in the concrete boat ramp. We have allocated funds for repairing the concrete boat ramp on a 25 year cycle beginning in 2032.

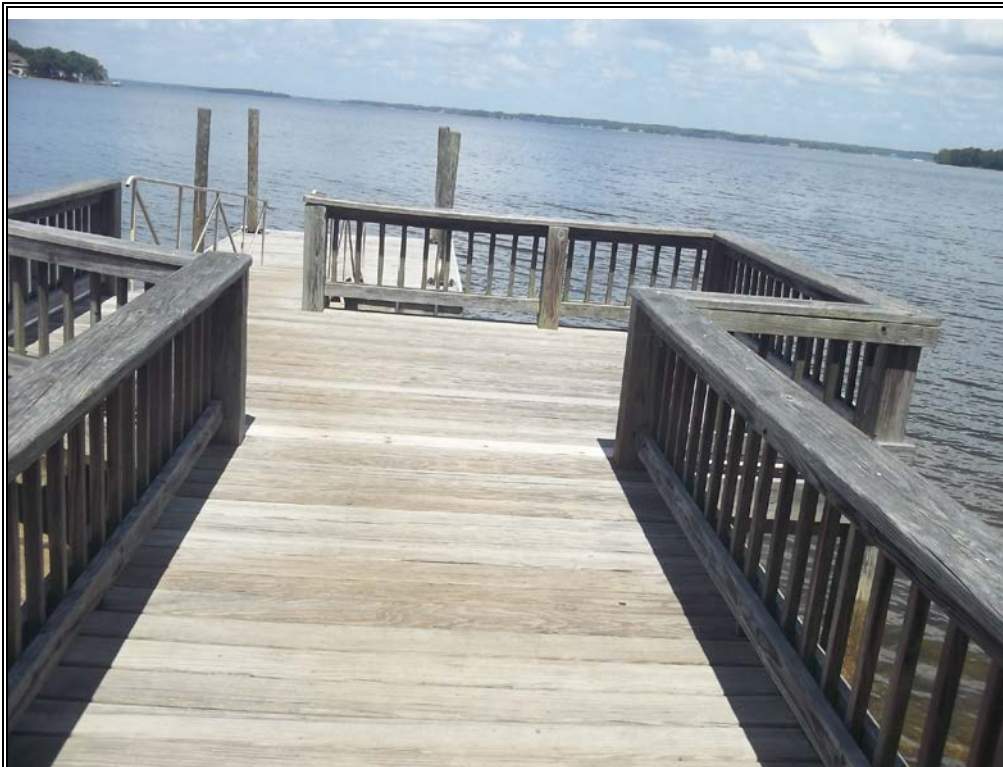
Photo Number
8

Description:
Wood dock at boat
ramp.

The association maintains the wood dock on the lake. This includes a wood framed platform with railings, a metal framed pedestrian ramp with wood decking and a floating wood dock with piling anchors. Wood decking components are beginning to show signs of age including warping, splitting and cracking. We have allocated funds to replace the wood decking and railings on a 15 year cycle beginning in 2020. We have allocated funds for full replacement of the dock including framing, floatation systems and pilings on a 30 year cycle beginning in 2035.

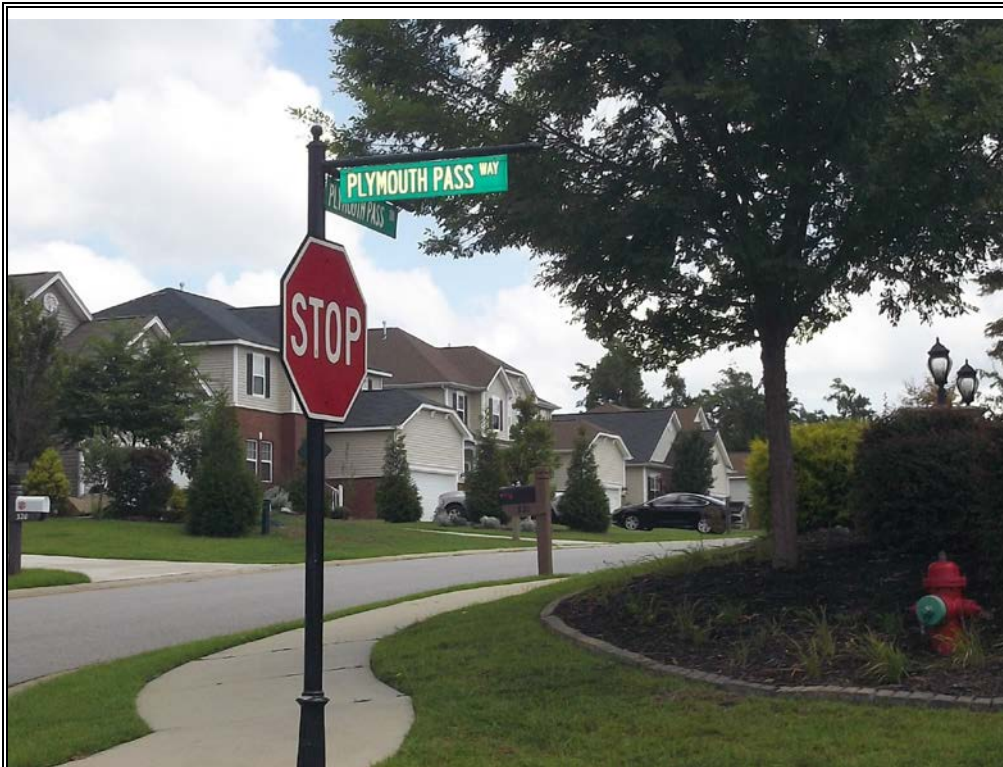
Street sign.

Custom street signs are located throughout the community. Typically the county/municipality will only maintain DOT standard street signs. We have assumed the association will be responsible for replacing the street signs. The signs appeared to be in good condition and have an expected useful life of approximately 20 years. We have allocated funds for their replacement in 2027.

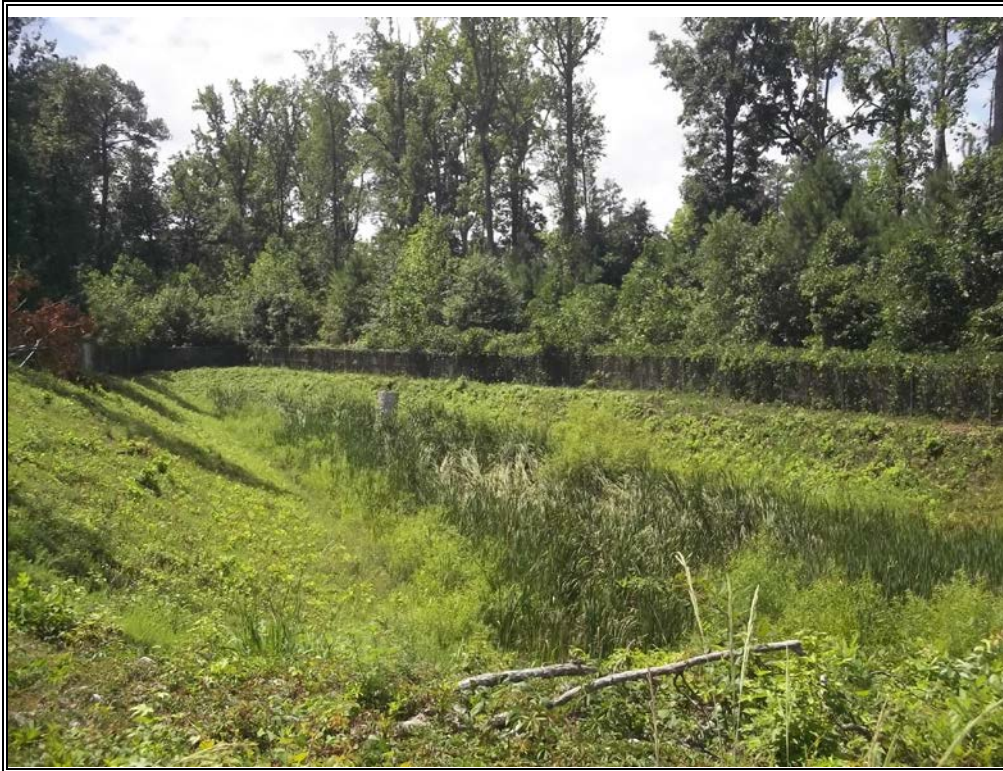
Photo Number
11

A dry retention pond is located behind the house at 209 Settlers Court. The dry pond includes an earthen dam and a galvanized corrugated metal riser structure. The pond is significantly overgrown with vegetation and inlet pipes and outlet pipes were not visible. The pond includes a perimeter fence comprised of a chain link fence and wood privacy fencing. The fencing was observed to be in poor condition with significant vegetation growth on the fencing and sections of fencing observed to be failing.

Description:
Dry pond behind
209 Settlers court.

We have provided an allocation of funds in 2017 and on a 15 year cycle for major repairs to the stormwater ponds. Immediate repair needs include substantial removal of overgrown vegetation and repairing riser structures and inlet piping. The association should also locate the original stormwater pond design documents including as-built drawings and operations/maintenance manuals for the stormwater ponds. Future repairs would likely including removing accumulated sediment, repairs to pond infrastructure including riser structures and dams/embankments.

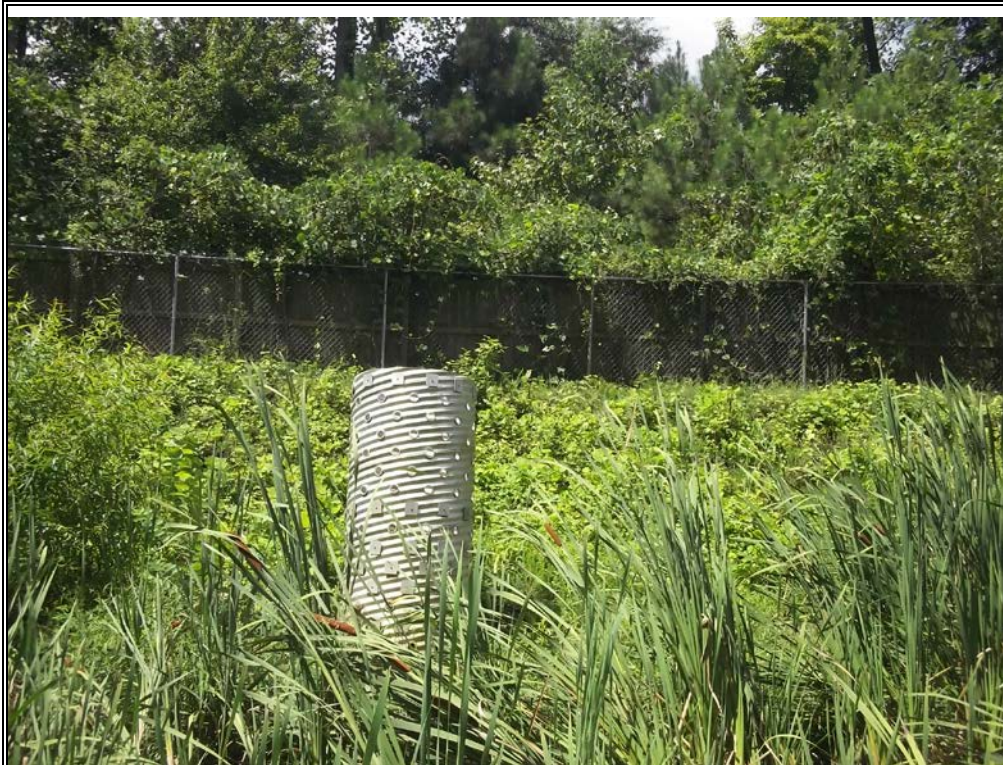
Photo Number
12

Description:
Leaning
galvanized riser
structure,
overgrown
vegetation in pond
and on fence.

We have allocated funds to replace the fencing around the two ponds noted above on a 20 year cycle beginning in 2021.

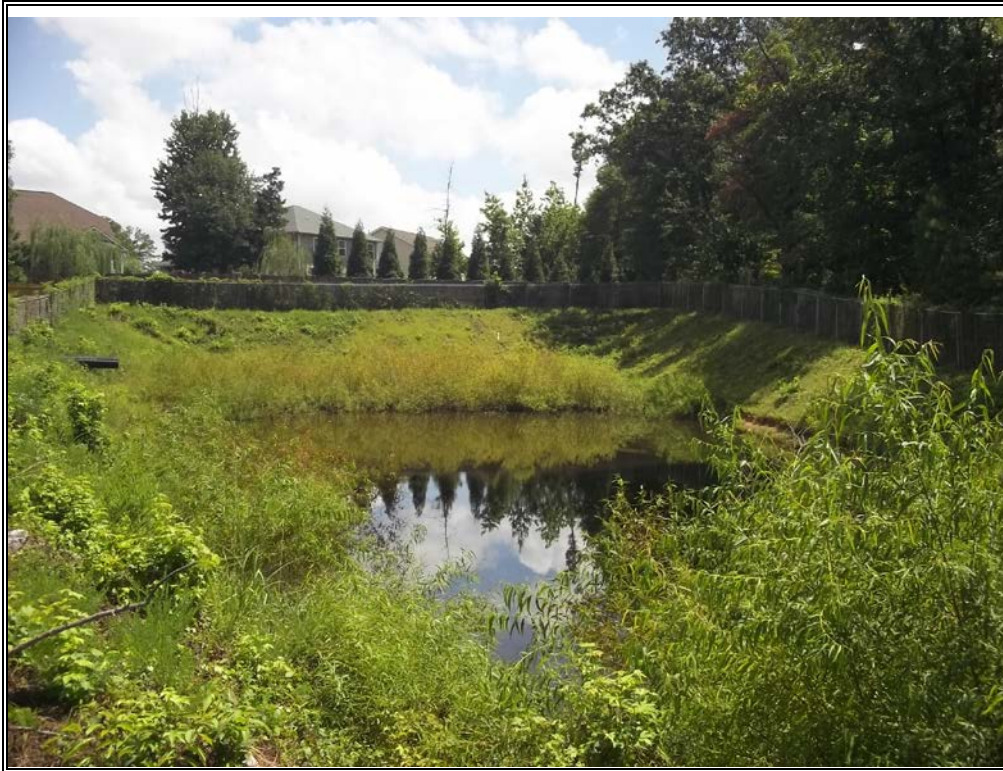
Photo Number
13

A second stormwater pond is located behind 105-117 Settlers Court in the community. The pond includes an earthen dam and a galvanized metal outlet pipe. An inlet pipe was observed in the pond embankment. The area around the outlet pipe and around the pond is significantly overgrown with vegetation. The pond includes perimeter wood and chain link fencing that was observed to be in poor condition with sections leaning and significant vegetation growth on the fencing.

Description:
Stormwater pond
behind 105-117
Settlers Court.

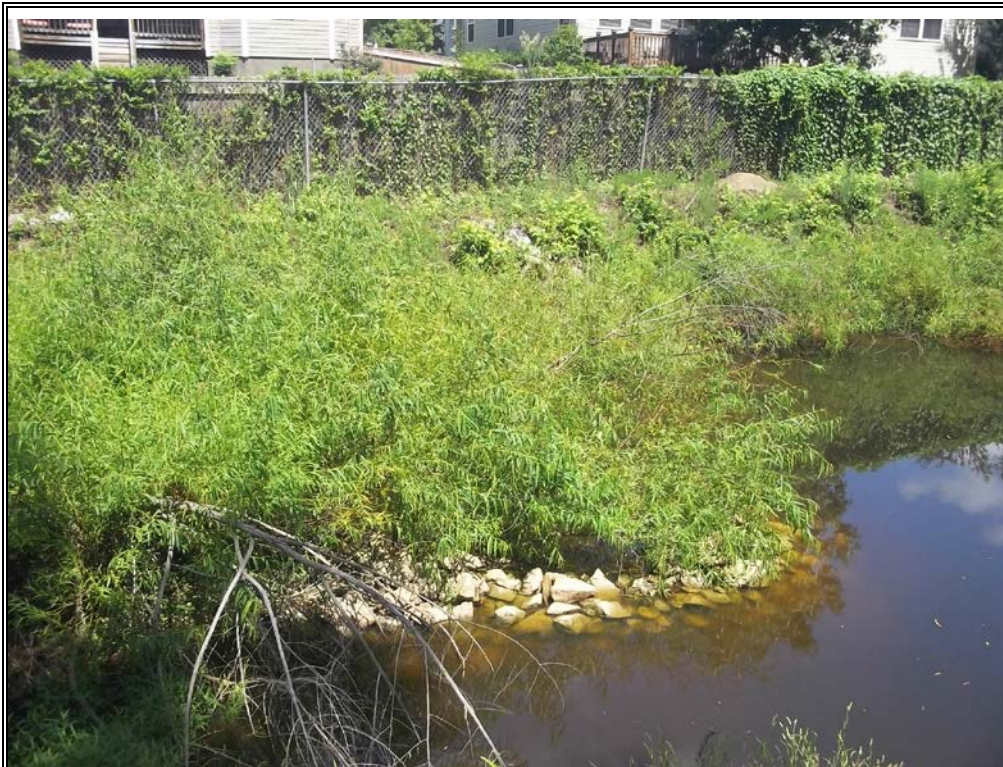
Photo Number
14

Description:
Overgrown
vegetation
blocking outlet
pipe. Overgrown
vegetation on
fence.

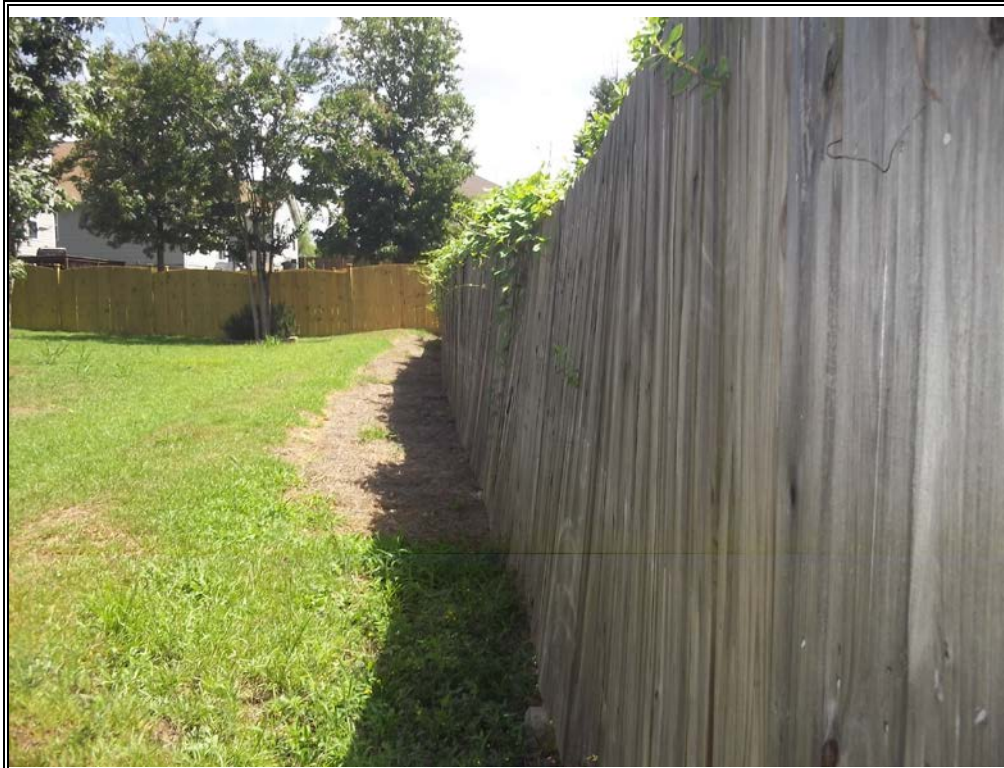
Photo Number
15

Description:
Leaning wood
fence at
stormwater pond.

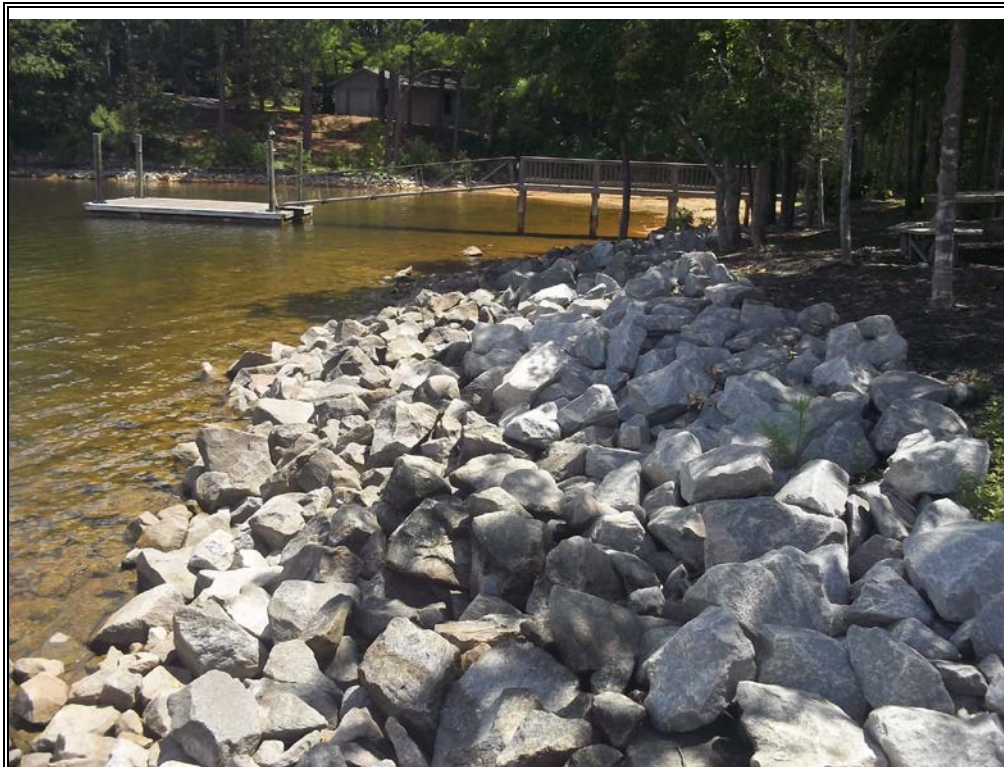
Photo Number
16

Drainage systems in the common areas include grassed and stone rip rap armored drainage swales and embankments. Stone rip rap armoring is installed along the lake shoreline at the boat dock area on Lake Murray. Catch basins in the paved and landscaped areas lead storm water via buried piping to three storm water retention ponds in the community.

Description:
Stone rip rap
shoreline
armoring.

In addition to major repairs to the ponds, periodic common area drainage improvements will likely be required. This would include reinforcing stone rip rap shore stabilization at the boat dock area, resurfacing gravel around the boat dock area, repairing erosion, stabilizing soils, adding ground cover, re-trenching/re-armoring swales, repairing sections of buried stormwater piping and possibly installing additional drainage systems. We have allocated funds for these repairs on a 7 year cycle beginning in 2020.
